Manhole Inspection Summary

Manhole # S39SS_021MH

Insp Date: **4/6/07 9:25 AM**

Location Address: **2700 LOCH RAVEN BLVD**

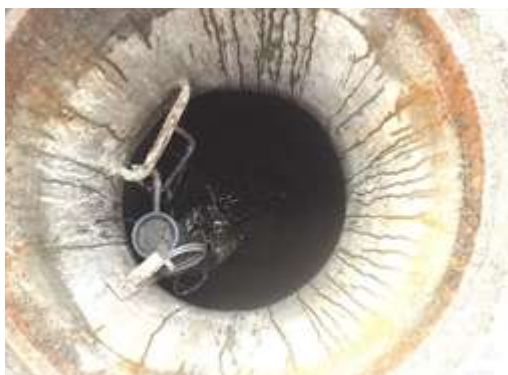
Defect

☒ **Leaks**

Infiltration: ☐ None ☒ **Joint** ☐ Cracks ☐ Mortar ☐ Roots ☐ Wall

Frame leaks. Adjustment infiltration.

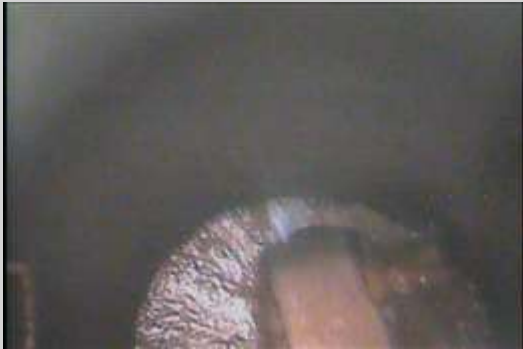
33 in. Circular Gravity Sewer Pipe Out @ 12 O'Clock

Invert Depth: **24.70** (ft.) Flow Characteristics: **Fast**

Infiltration: **None** Pipe Seal Cond: **Unknown**

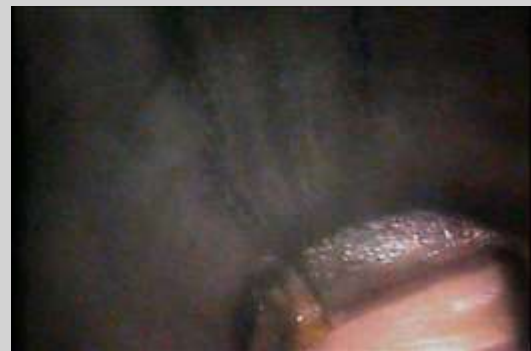
Drop In @ 3 O'Clock

Drop Condition: **Partly Clogged**

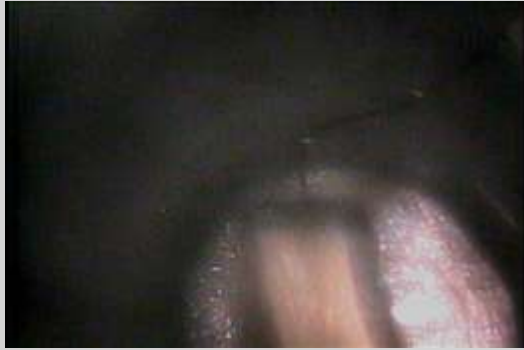
24 in. Circular Gravity Sewer

Invert Depth: **24.25** (ft.) Flow Characteristics: **Fast**

Infiltration: **None**
